Monitoring Data Record

Project Title: U-2524AB (Site 3) COE Action ID: 200321137
 Stream Name: UT #3 Reddicks Creek DWQ Number: 030909
 City, County and other Location Information: Greensboro Western Loop, Guilford Co.
Sta. 34+00 to Sta. 37+10 -L-
 Date Construction Completed: Water was turned into the stream on June 2005 and planted
January 2007. Monitoring Year: (1) of 5
 Ecoregion: _____ 8 digit HUC unit 03030002
 USGS Quad Name and Coordinates: _____

UT #3 Reddicks Creek

Year 1 Summer – July 2007

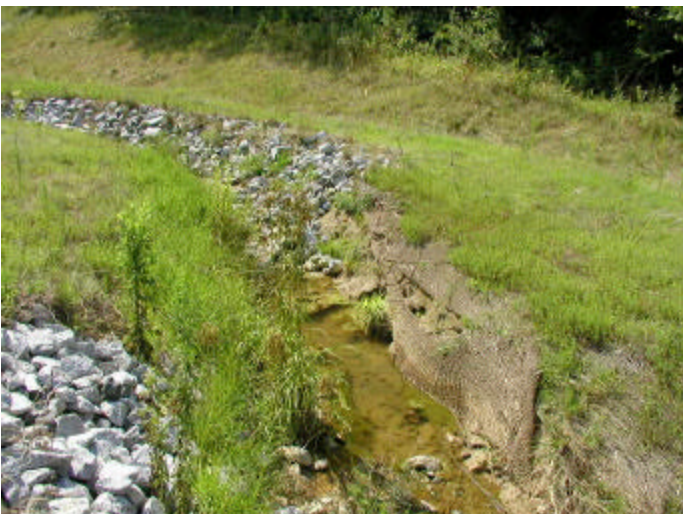
Photo Point #6 (Upstream)

The UT #3 Reddicks Creek stream relocation is stable for the Year 1 summer evaluation. There is some minor bank scouring (PP #6 Upstream) noted along the left bank at approx. Sta. 36+80. NCDOT will continue to monitor this stream relocation.

7/19/07	Sta. 36+80	Station Number	Station Number	Station Number	Station Number
Structure Type					
Is water piping through or around structure?					
Head cut or down cut present?					
Bank or scour erosion present?	Minor bank scouring
